# Manhole Inspection Summary

Manhole # S07SS1016MH

Insp Date: **11/14/08 9:12 AM**

**Location** Address: **WINNER AVE**

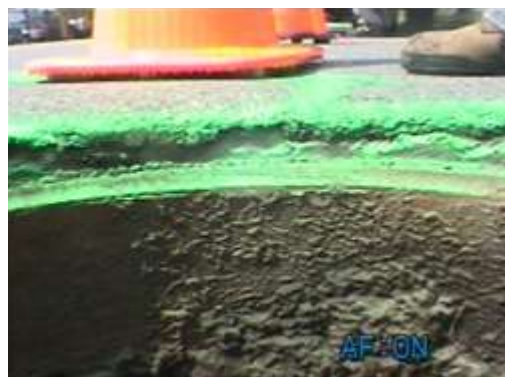
Defect 2

Condition: ☐ Sound ☒ **Cracked** ☐ Leaks

CRACKED AND BROKEN RIM ON FRAME

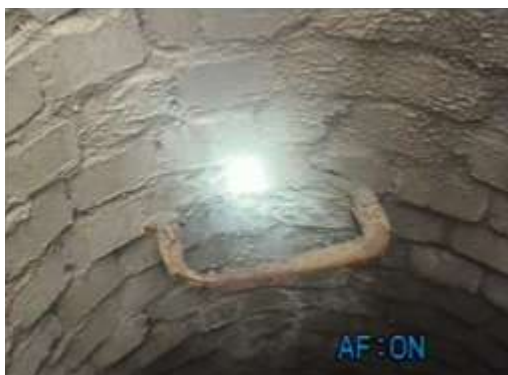
Defect 1

Count: **6** Missing: **1** ☒ **Corroded**

CORRODED RUNG

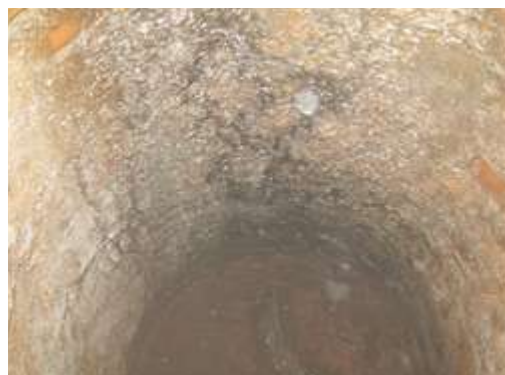
Defect 5

Infiltration: ☐ None ☒ **Joint** ☐ Cracks ☐ Mortar ☐ Roots ☐ Wall

Corbel infiltration

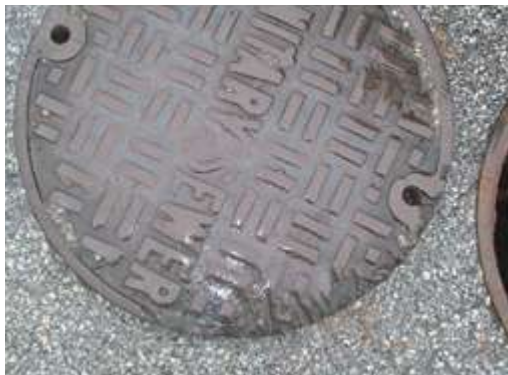
### Defect 3

Condition: **Worn**

Worn condition

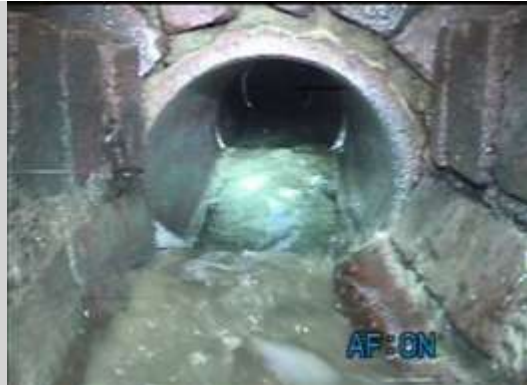
12 O'Clock Outflow

Infiltration: **None** Pipe Seal Cond: **Cracked**
